# Corrosion Evaluation of Underground Telephone Cable Shielding Materials

W. F. Gerhold and J. L. Fink

April 1981

Progress Report  
1976-1980

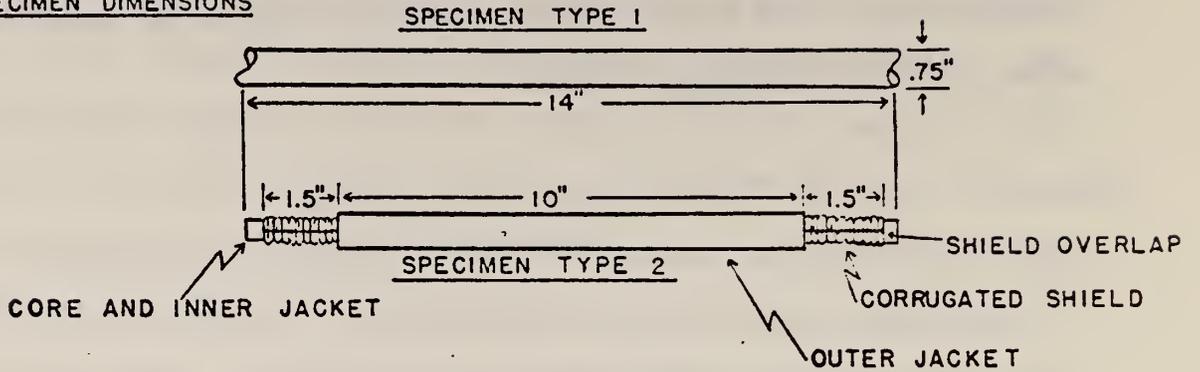
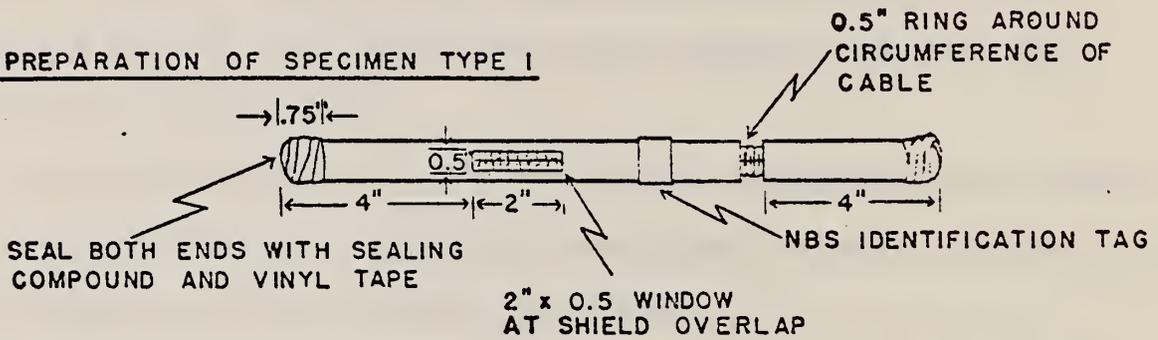
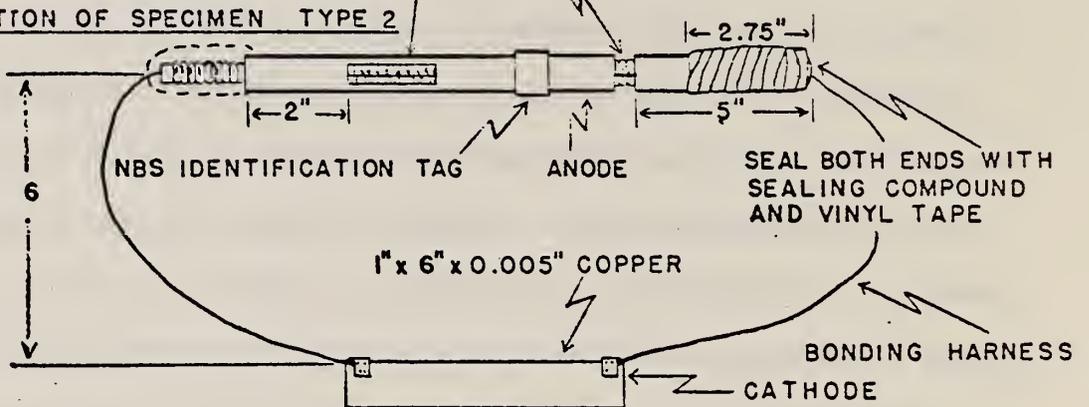
Figure 1 Preparation of specimens for cable exposure tests

PREPARATION OF SPECIMENS  
FOR CABLE EXPOSURE TESTS

SPECIMEN DIMENSIONS

PREPARATION OF SPECIMEN TYPE 1

PREPARATION OF SPECIMEN TYPE 2

In order to expose the shield material to the environment and to simulate conditions which may occur in field installations of telephone cables, specimens were prepared as shown in figure 1. Specimens used in this study were polyethylene jacketed cable lengths [approximately fourteen inches (35.6 cm) long] containing metallic or plastic coated metal shields. With a few exceptions, the shield was exposed by stripping the outer polyethylene protective jacket at two areas, one each approximately four inches (10.2 cm) from either end of the cable length, creating a window and a ring. The window was an exposed area along the length of the cable approximately two inches (5 cm) long x 0.5 inch (1.3 cm) wide, while the ring was an exposed area 0.5 inch (1.3 cm) wide around the circumference of the cable. In addition, some of the systems were electrically coupled to copper strips by mechanically bonding the strip to electrical wires which were in turn mechanically bonded to the shield at the ends of the cable. Coupling the shield to copper thus created a galvanic cell between the copper and the shield material. This was done to simulate field conditions in which dissimilar metal shields may be coupled either to existing cable systems having copper shields or to copper ground rods. The ends of the specimens were sealed with a sealing compound and wrapped with vinyl tape to prevent entry of moisture at the end areas.
